TROUBLESHOOTING GUIDE COUNTER-TENSIONED SYSTEMS

Standards and guidelines are usually used as a basis for assessing sun protection systems, including their installation. Based on those sources, and broadened to include technical characteristics of the relevant products and the state of the art, this guide covers the key issues and performance features of **WOUNDWO** counter-tensioned systems that are most frequently mentioned and occur most often.

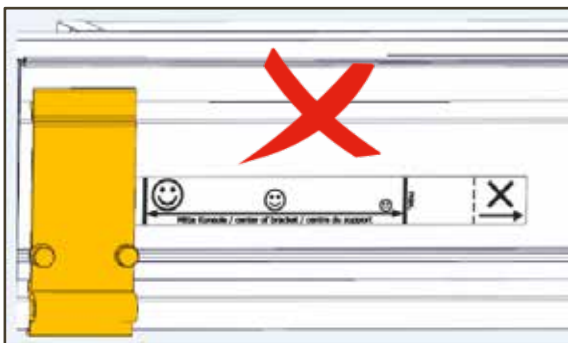
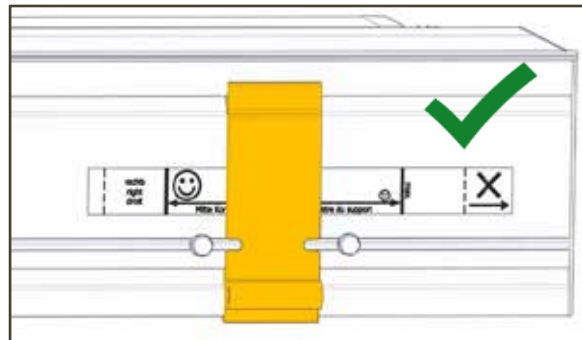
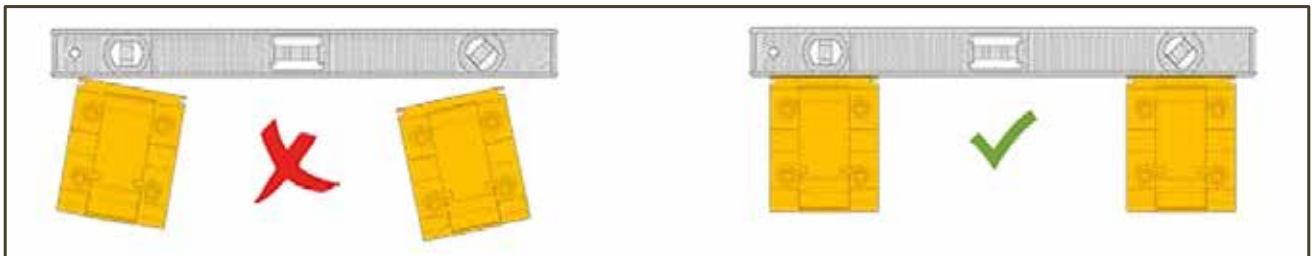
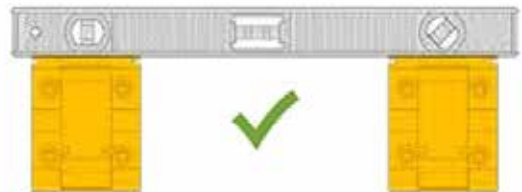
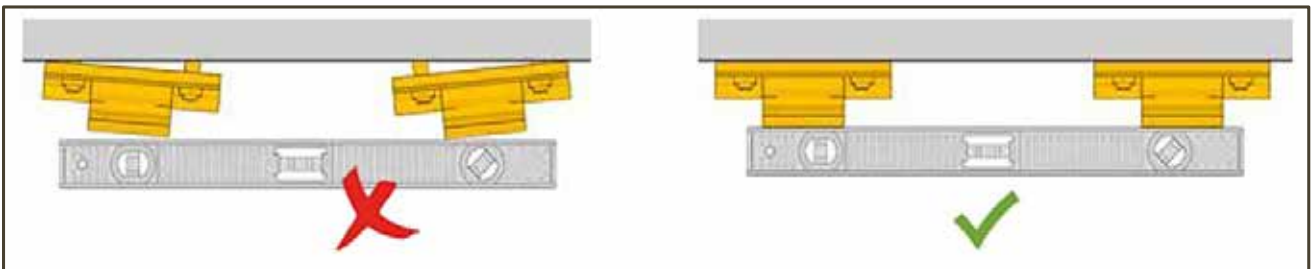
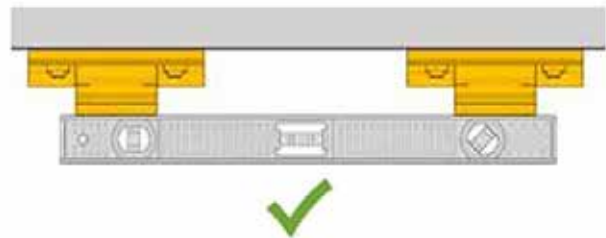
1.1 Position and alignment of the brackets

1. Awning / housing is skewed (Points 1.2 / 2.2 / 2.4)
2. Awning doesn't close properly (Point 2.1)
3. Awning makes noise when opening / closing (Point 1.4)
4. Revision profile of the awning is difficult to attach / remove

The correct positioning and alignment of the brackets is a prerequisite for trouble-free functioning. If brackets are incorrectly mounted, the malfunctions referred to above frequently occur.

Guidance: Mounting instructions

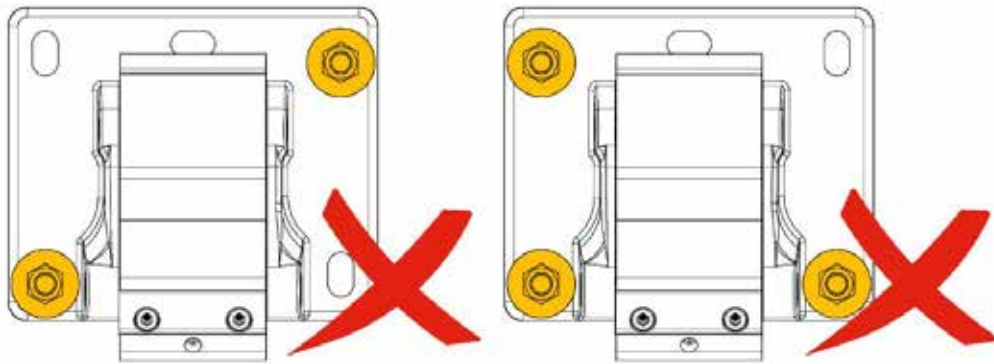
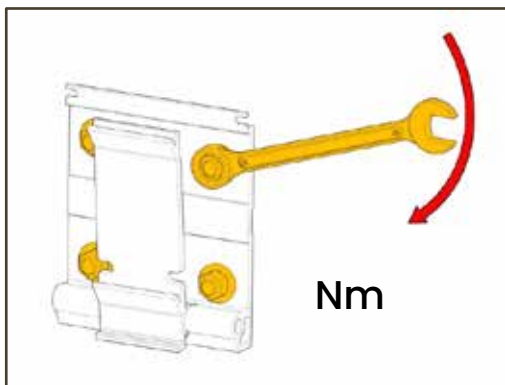
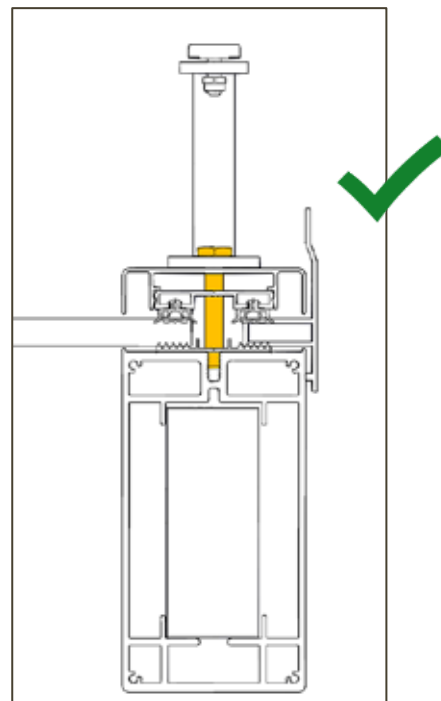
1.2 Installation and fastening

The number of screws / anchors must be adjusted for the specified brackets as per the mounting instructions. The fixing screws must be tightened properly. The relevant torques as per the manufacturer's instructions must be adhered to. An incorrect tightening torque (too tight or too loose) can result in damage such as fracturing of the anchors or loosening of the screw joints / nuts. Anchoring points that are loose or already detached are often a cause of damage and injuries. For example, if columns or distance brackets fail to hold and the guide rails are no longer parallel, or the entire system is no longer at right angles.

Torque of the fastening components as per manufacturer instructions.

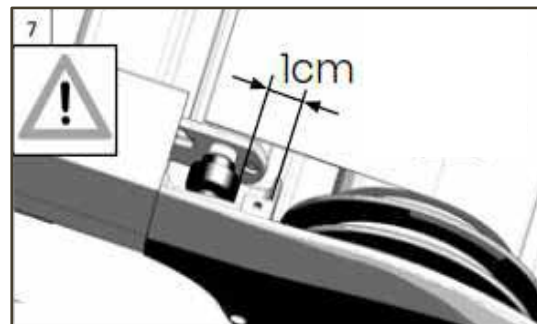
1.3 Tape / tape breakage

The tapes used are designed to be tough and durable. Nonetheless, they can still break. It must be determined whether the breakage is a result of ageing, or was caused by something else. Even with very heavy use, a tape will last many years. The following points are important in this context – they adversely affect the service life of the tapes or are a direct cause of damage or breakage:

3. Rear (upper) stop point of the motor (end position): the projection profile must be at least 1cm (preferably a little more) away from the rear stop bar. The projection profile must NOT strike against the rear of the casing / system housing – otherwise the tapes are loose when retracted and will slide off the rollers (in windy conditions). Simple adjustment aid: move the system as far as the rear stop bar – make a mark (pencil, sticky tape) on the rail – move the projection profile at least 1 cm away from the mark – record and retain this position as the rear end point (upper end position).

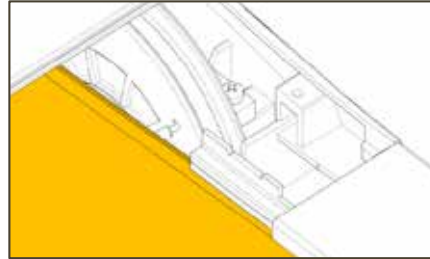
4. ZIP + guide inlay: ZIP must run smoothly in and into the ZIP guide inlay – higher friction when retracting the awning may cause the tapes to become slack, and they may fall off the rollers or deflection rollers (check each time before closing the cover).

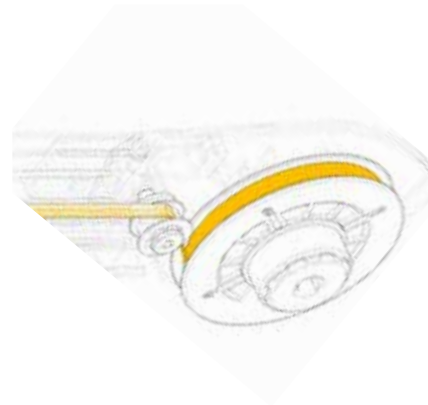
5. Tape: must not be twisted – if it is, correct this to prevent overloading.
6. Guide rails: must be properly aligned – parallel, not buckled or loose
7. Entire system must be at right angles: diagonal deviation max. 5 mm.
8. Spacer profiles / fabric support profiles: correct installation (see mounting instructions for pergola awnings) is necessary.
9. Tape guide: especially in the area of the infeed rollers in the casing, tapes must be guided correctly – otherwise they will rub or chafe and break.

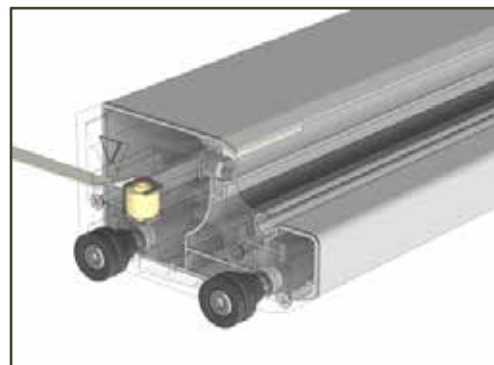
10. Wheels and rollers of the projection profile: clean and freely rotatable – otherwise, clean them and ensure they are running smoothly. Increased friction puts additional strain on the tapes.

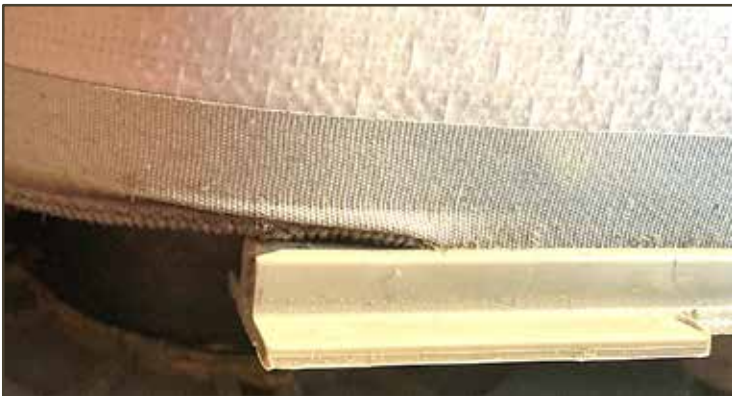
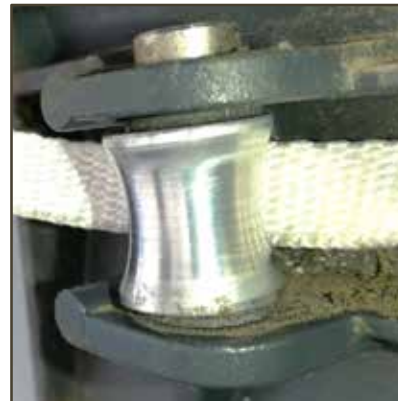
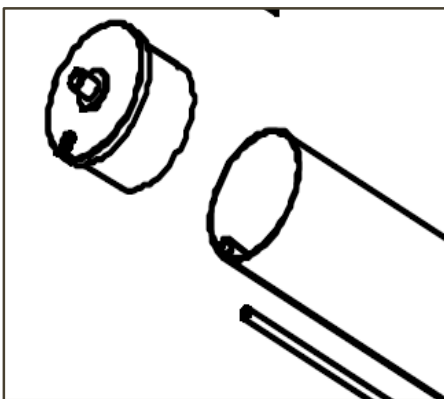
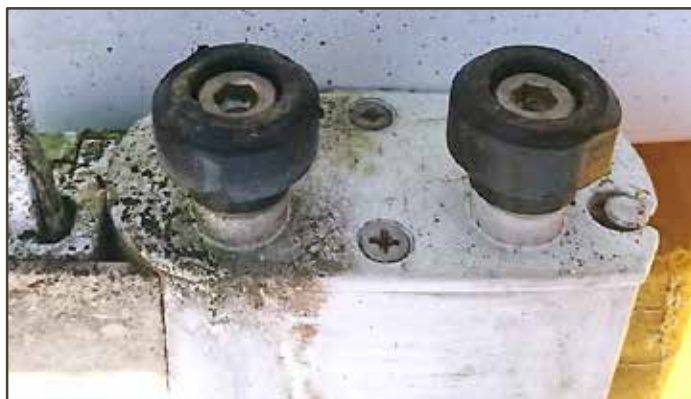
1 GENERAL INFORMATION**1.4 Noise when retracting / extending**

1. Deflectors at the end of the guide rails
2. ZIP in the ZIP guide inlay
3. Casters of the fallbar
4. Infeed rollers in the housing / casing, via which the tape is guided onto the tape discs.
5. Seating of the roller tube on the tape discs (insufficiently lubricated, dried out)
6. Tension springs in the roller tube
7. Roller capsule

Apart from operating noises that occur when the system is moving and when opening and closing the brake (a kind of 'click'), moving parts such as rollers, wheels, springs, ZIP, etc. can make noise. These noises are not usually regarded as problematic. Any noises beyond this, sometimes described as squeaking, whistling, creaking or cracking, indicate one of the problems referred to above.

Guidance: Mounting and maintenance instructions

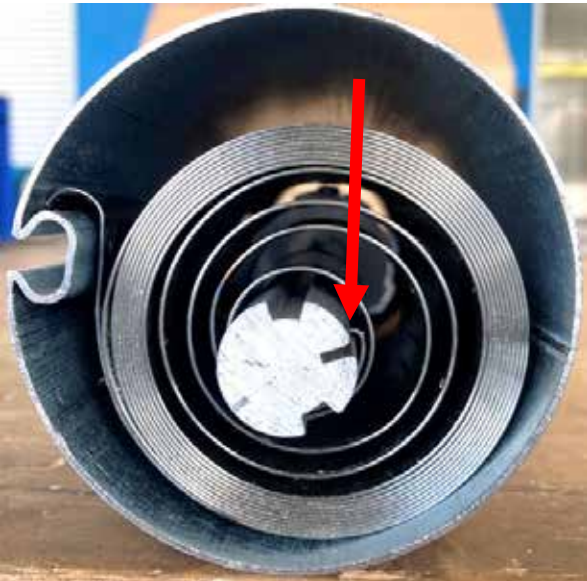
Good spring in roller tube

Sometimes, systems cannot be tensioned or can no longer be tensioned correctly. The reasons for this are almost always servicing or repairs carried out previously, such as changing the fabric, replacing the motor or adjusting the settings. What has happened?

During servicing and repair work, it **MUST** be ensured that the motor is **NEVER** used to extend the awning while not allowing the roller tube to rotate. If the motor inside rotates in the direction of extension and the roller tube remains stationary, the motor pushes the tension springs in the wrong direction. This enlarges the internal diameter of the springs and they no longer sit in their mounting, or sit improperly. This means that they slip through and cannot be tensioned or can no longer be adequately tensioned.

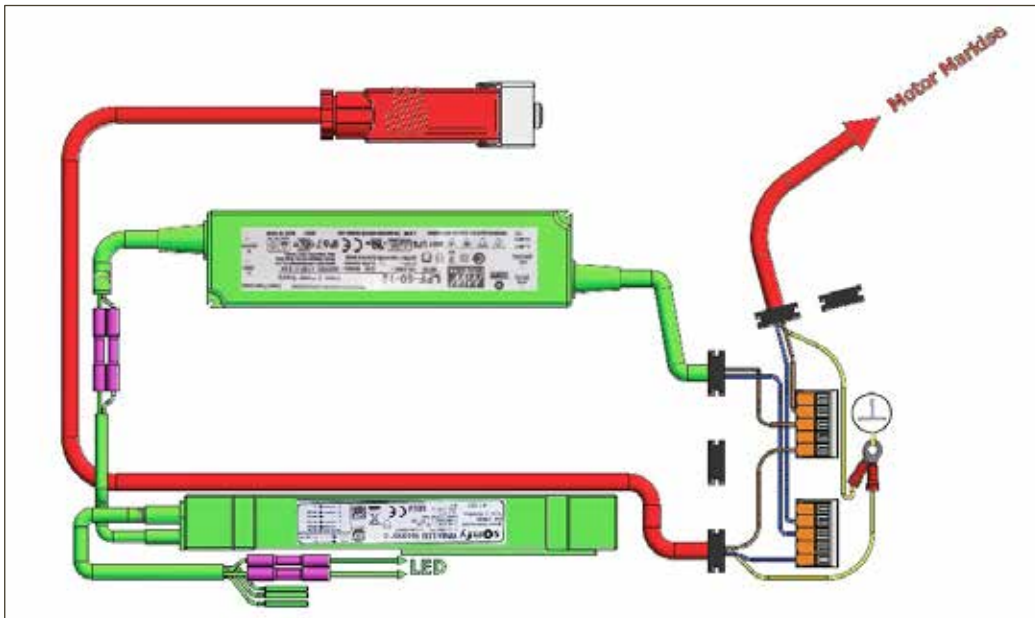
1.7 LED doesn't switch on

There are 5 possible reasons why an LED that previously functioned no longer works.

1. The power supply is interrupted (supply line to the transformer and battery in the transmitter)
2. The transformer is defective
3. The radio transmitter is defective
4. The radio receiver is defective
5. The LED strip itself is defective

The only way to identify the faulty component is to check the individual parts one by one. It is best to start with the transmitter (battery, other transmitter) and then check the supply line (measure input voltage) and the transformer (measure output voltage). If all of this produces no result, the final step is to check the radio receiver and LED strip.

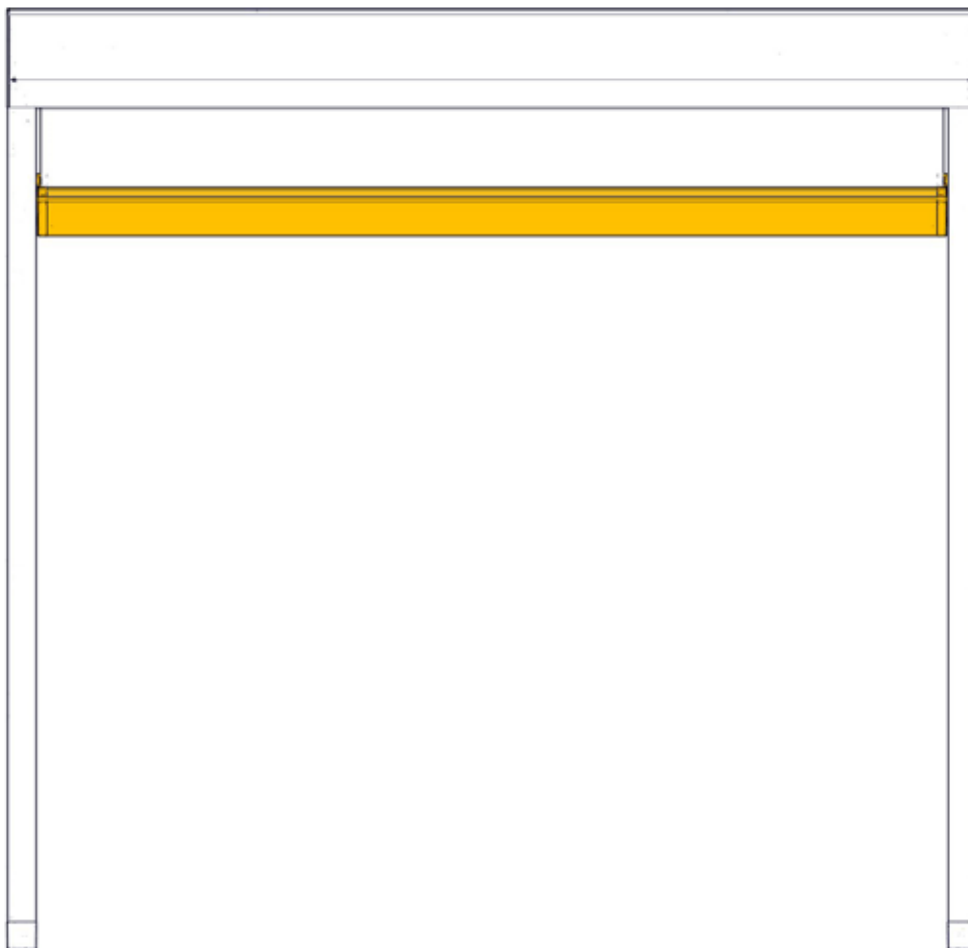
2 FRAME / MECHANISM**2.1 Awning doesn't stop correctly (inner end position)**

1. Awning is skewed (fallbar strikes against the housing) – check bracket installation (Points 1.1, 1.2)
2. Awning sits too wide open – adjust end position
3. Awning retracts too far (tape is slack) – adjust end position

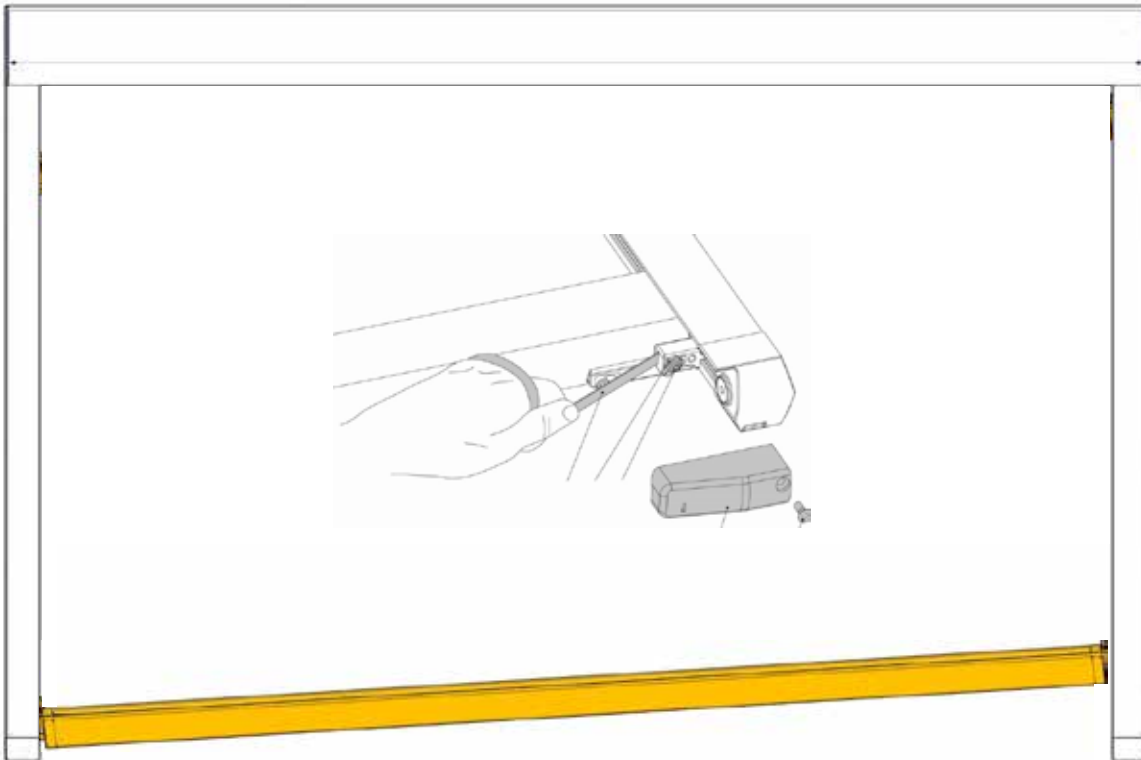
2.2 Projection profile isn't straight on the outside (unequal distance to the end of the guide rails)

1. Different tape lengths (as a result of uneven tape fixation on the projection profile)
2. Differences in the tape thickness (tape tolerance)
3. Uneven safety windings on the tape discs (left 1 rotation – right 2 rotations)

Point 1+2: On the side that is further to the outside (in the image below, it's on the left), hold the tape, loosen the fixing screw and slacken the tape. The profile moves inwards; loosen until the profile is straight and then tighten the fastening again.

Point 3: Align the safety windings.

Important: After all points, the end positions must be reset!

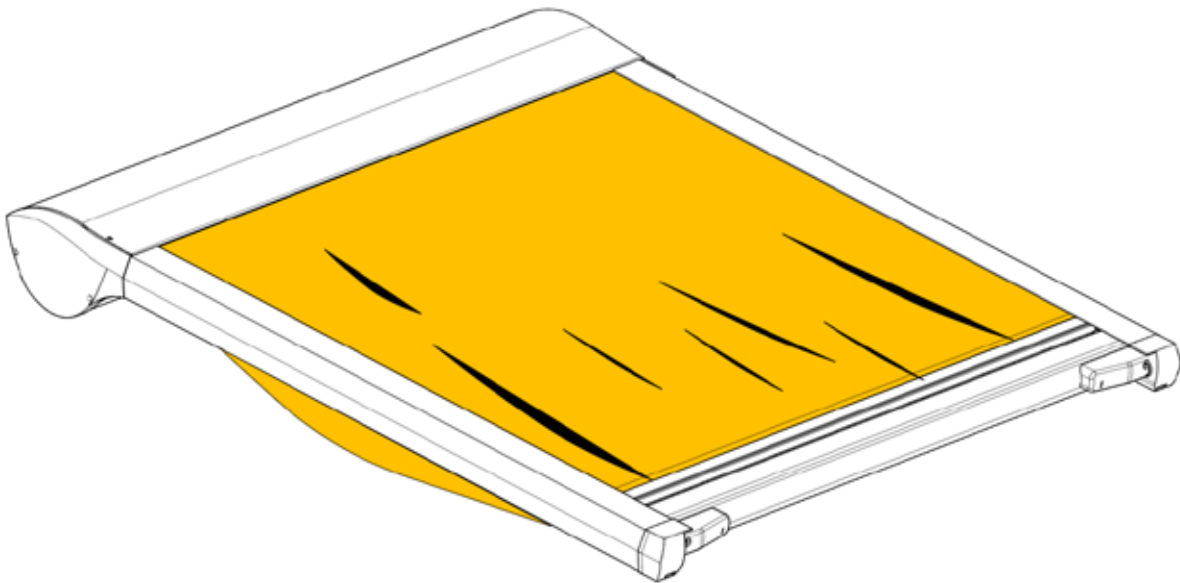
3 CURTAIN / FABRIC**3.1 Fabric is sagging**

1. On the side with sagging, the tape is not tensioned tightly enough.
2. The fabric is overextended on one side – this can happen, for example, after a tape has broken, if the entire tension force is acting on one side of the fabric and overstretches that side, or if the projection profile becomes jammed and the full pulling force of the motor is acting on one side of the fabric.

With tensioned fabrics, it must be accepted that a certain amount of sagging will occur. This sagging will be more or less noticeable depending on the size of the awning and what awning system is used. In addition, the sagging is affected by the fabric itself (weight, type of fabric) and other factors such as humidity or wind (stretching of the fabric). This type of sagging is inevitable even with the most careful manufacturing and processing of the fabrics.

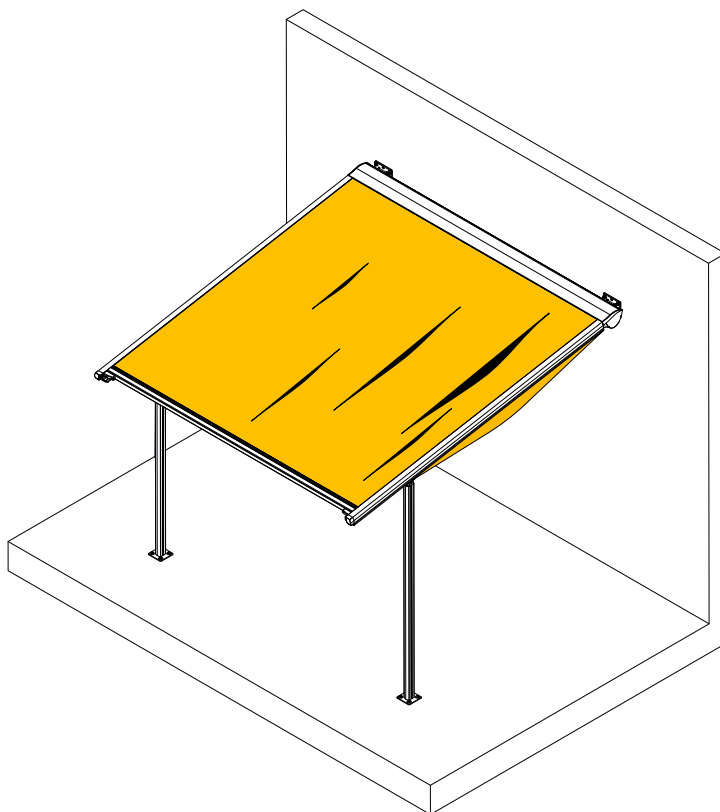
3.2 Fabric has folds or rippling

Small ripples, 'honeycomb' patterns or folds are often seen, especially in the area of seams and hems. These variations occur as a result of different roll-up diameters between the seams, where the fabric is twice as thick as in the flat area between the seams, where it is only a single layer. This means that, when they are wound onto the shaft, these areas are subjected to differing levels of stress resulting in these folds or rippling. This is usually intensified by moisture (humidity).

In models with ZIP (lateral zipper), crease formation in the transition area is almost inevitable due to differing materials, processing technology and roll-up characteristics. Some stripes that may seem lighter or darker are also perceived as creases. These are creases and wrinkles due to handling that arise due to the unavoidable laying down, folding or rolling of the fabrics during processing. These variations have no effect on the function and lifespan of the fabrics and do not represent any deterioration.

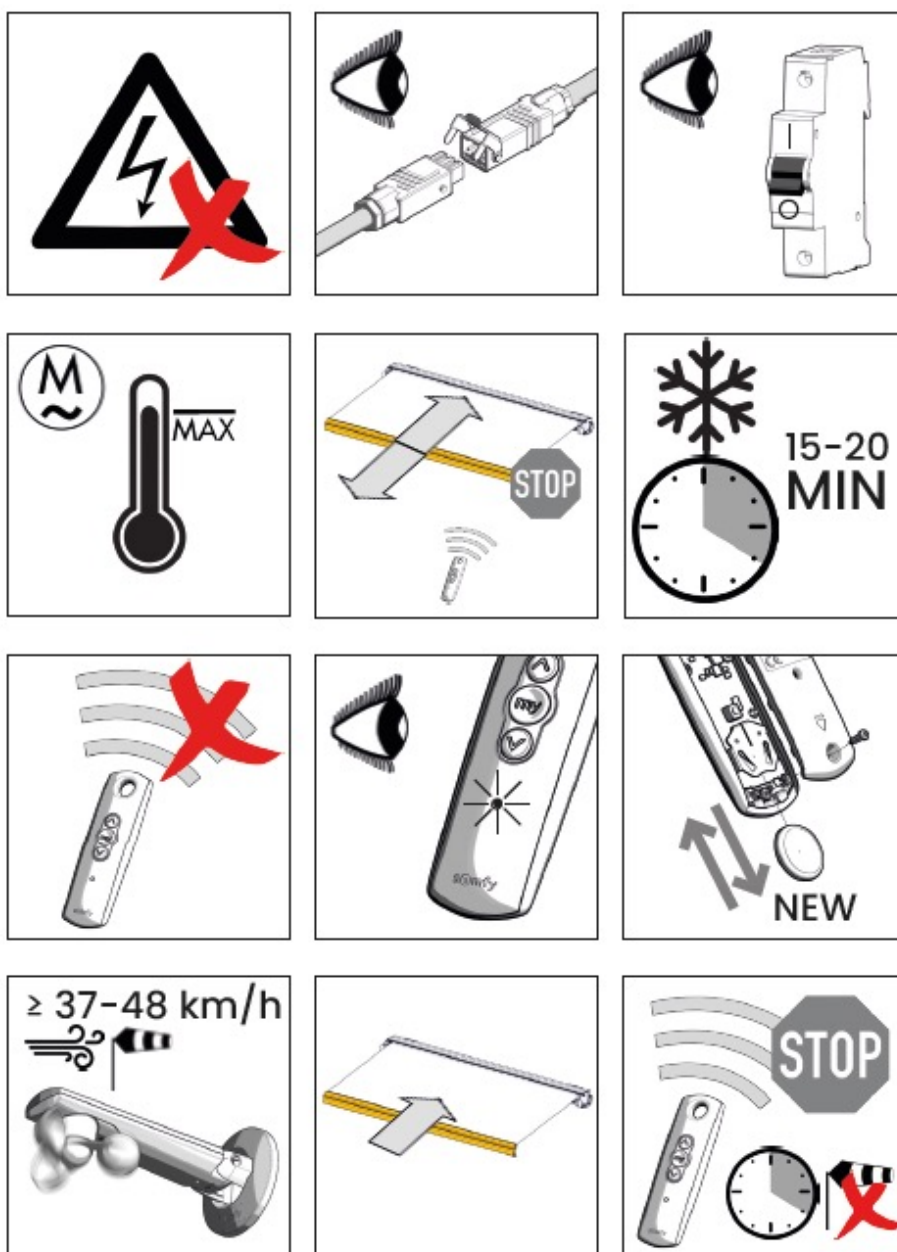
4.1 Awning motor no longer works

When motors stop working, this can often be traced back to one of the following causes:

1. Wind prevents extension (locked by wind sensor)
2. Radio transmitter doesn't work (empty battery, defective transmitter)
3. Motor has no power supply (no current)
4. Motor overheating (operated too often)

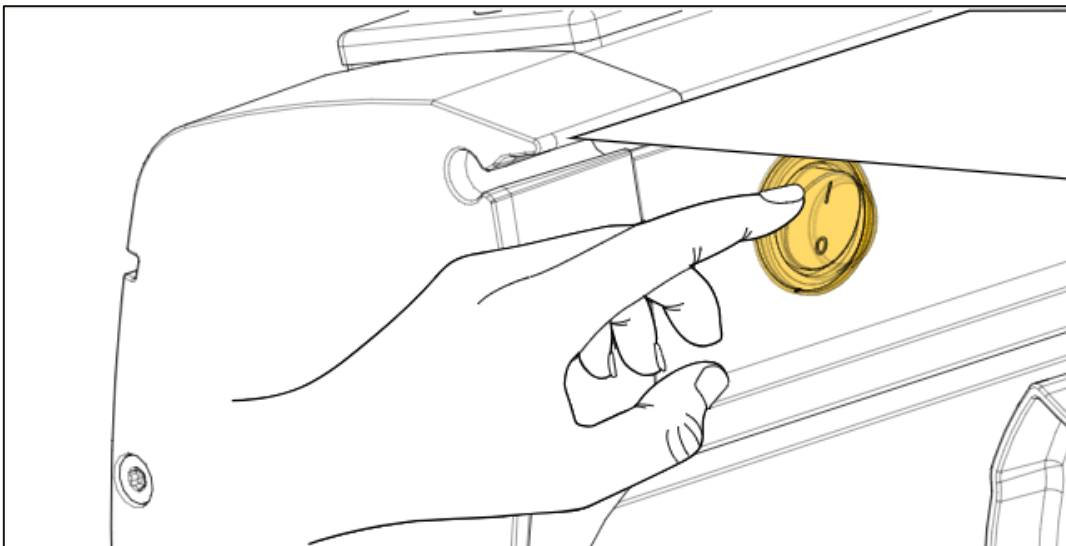
4 DRIVE / OPERATION**4.2 Solar motor of the vario valance no longer works**

1. Radio transmitter doesn't work (empty battery empty, defective transmitter)
2. Motor overheating (operated too often)
3. The power supply is switched off

For vario valances manufactured from 04/2024, you will find a toggle switch in the projection profile, on the inside under the fabric. This must be switched on so that the motor is connected to the battery (power supply).

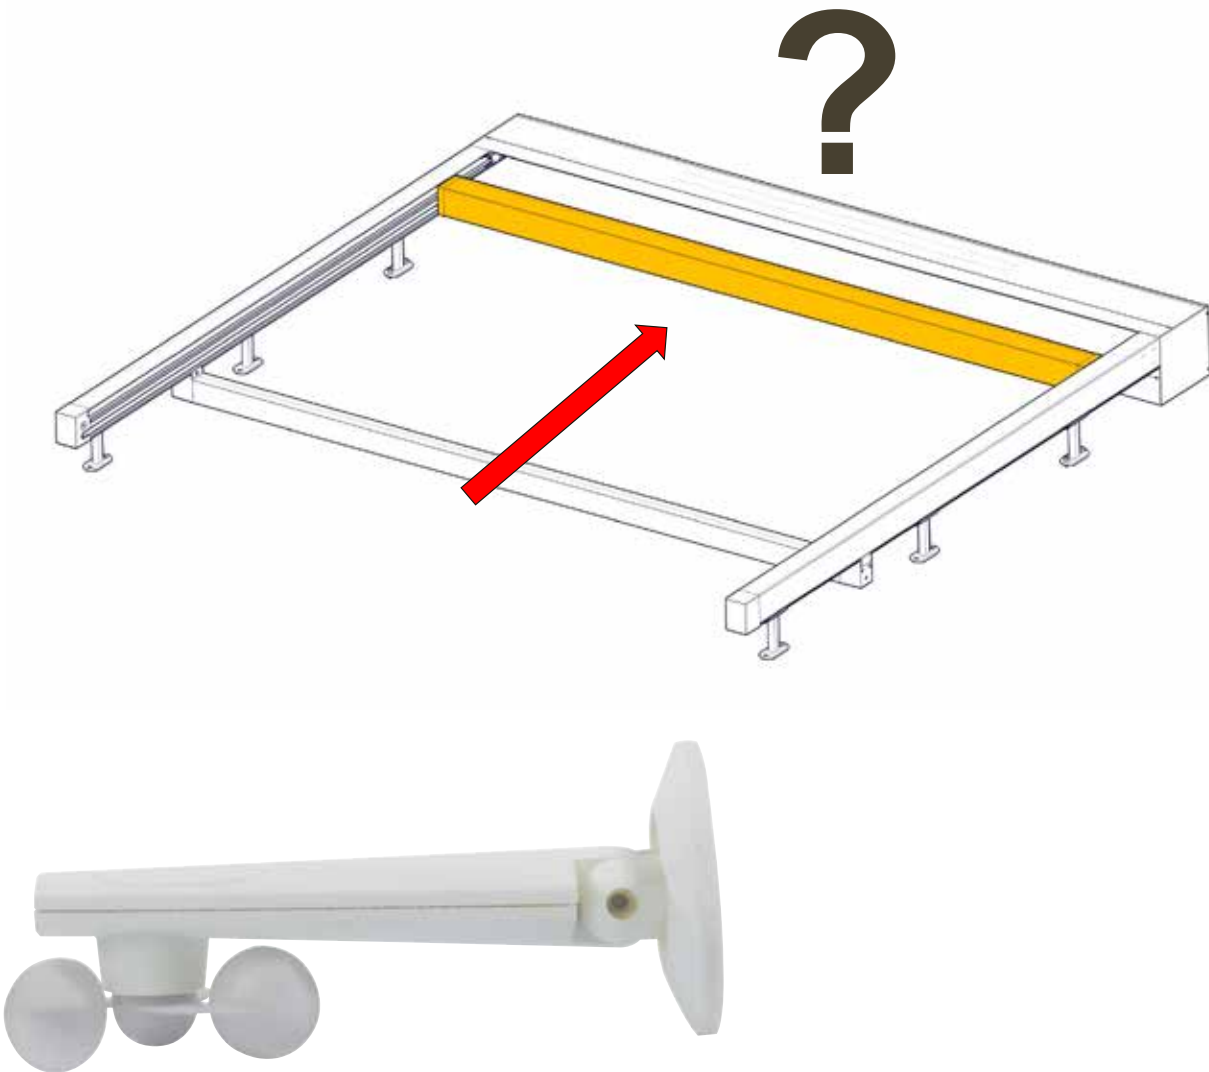
4.3 Awning retracts by itself

If awnings periodically retract on their own (approx. 30 minutes after being extended), even though there is no reason for them to do so (no wind, no darkness), this is a signal that the battery for the wireless wind sensor is empty. Replacing the battery will rectify this.

If the wireless wind sensor was previously replaced because it was defective, this is an indication that the old (defective) wind sensor that was removed has not been deleted from the motor memory. To make the automatic retraction stop, the old wind sensor must be deleted from the motor memory.

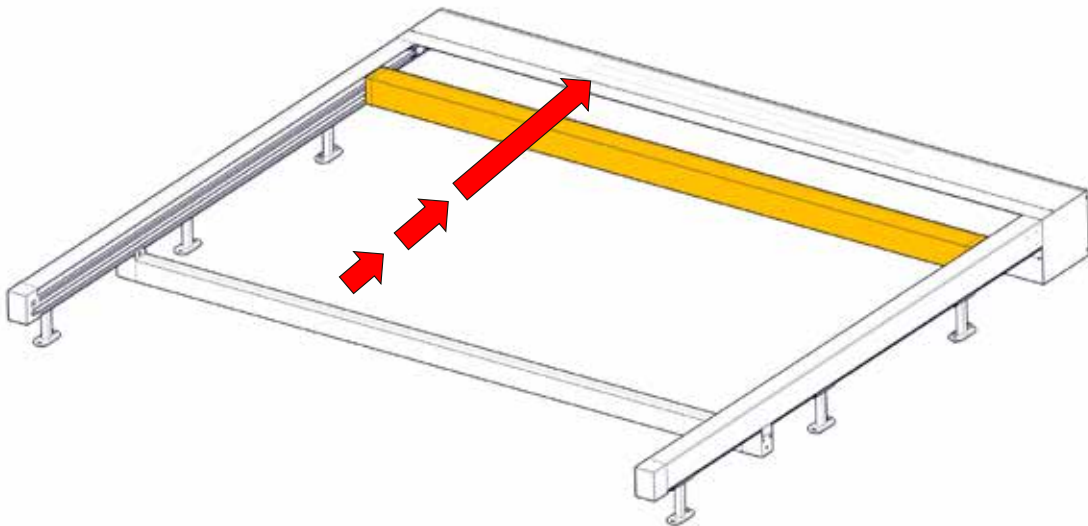
4 DRIVE / OPERATION**4.4 Awning randomly retracts**

If counter-tensioned systems retract randomly, the cause is inadequate tensioning of the springs. This tends to occur in systems with ZipRail systems. If during retraction the friction of the ZIP in the guides is greater than the preloading of the springs, the profile will stop until the springs are wound tightly enough. Then the projection profile will move up. The whole process may be repeated 1-2 times.

Increasing the tension helps here.

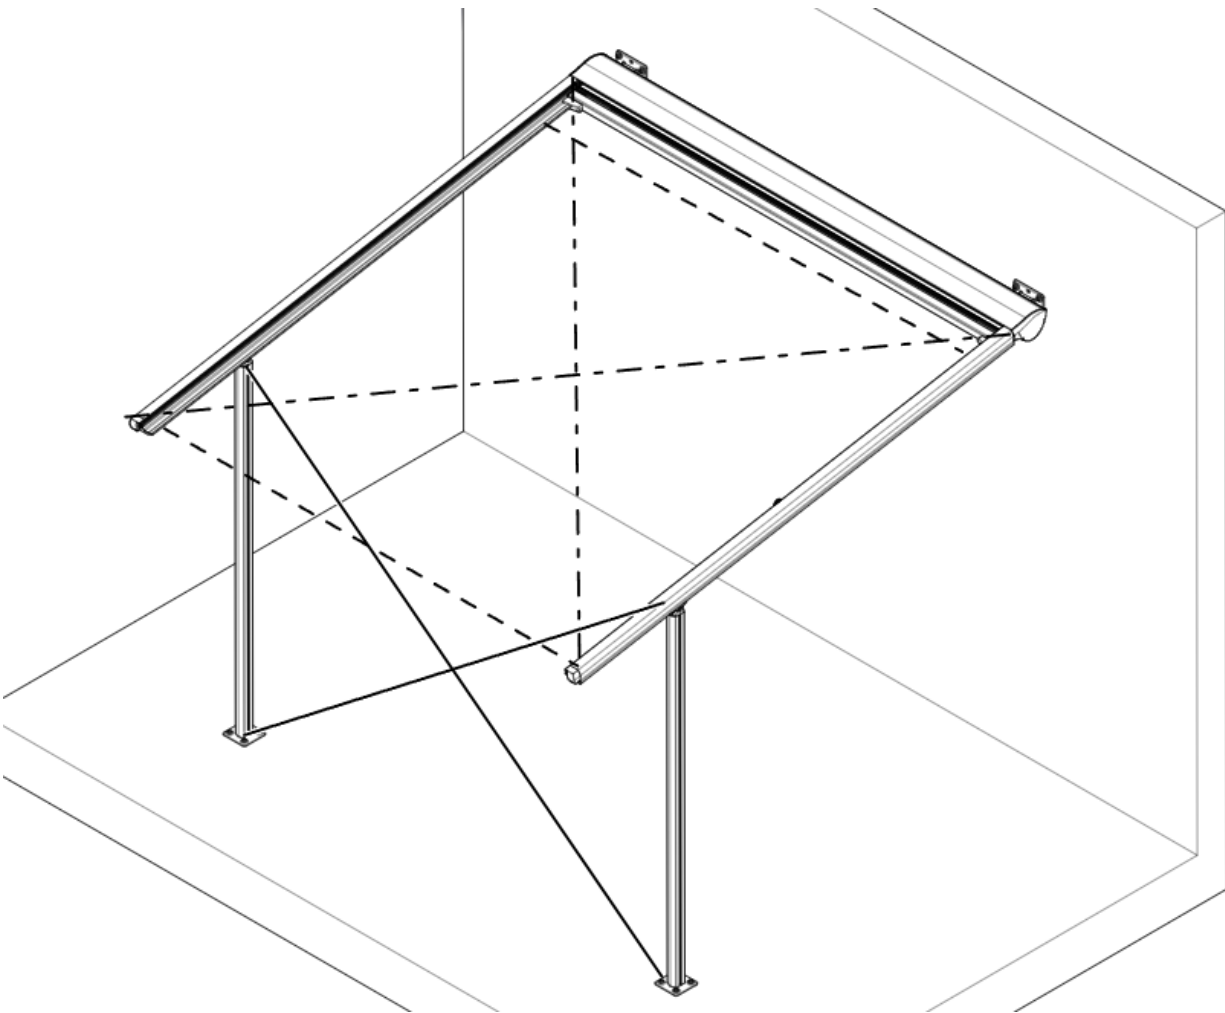
5.1 Alignment of the rails

The guide rails must be parallel and the system must be at right angles. The tolerance for the diagonals is max. 5 mm difference!

Discrepancies in the width of the guide rail can be clearly seen in the varying clearance between the projection profile and the rails when extending and retracting.

Variations in the angle (diagonal dimension) cause creases to form in the fabric, starting from one of the rear corners.

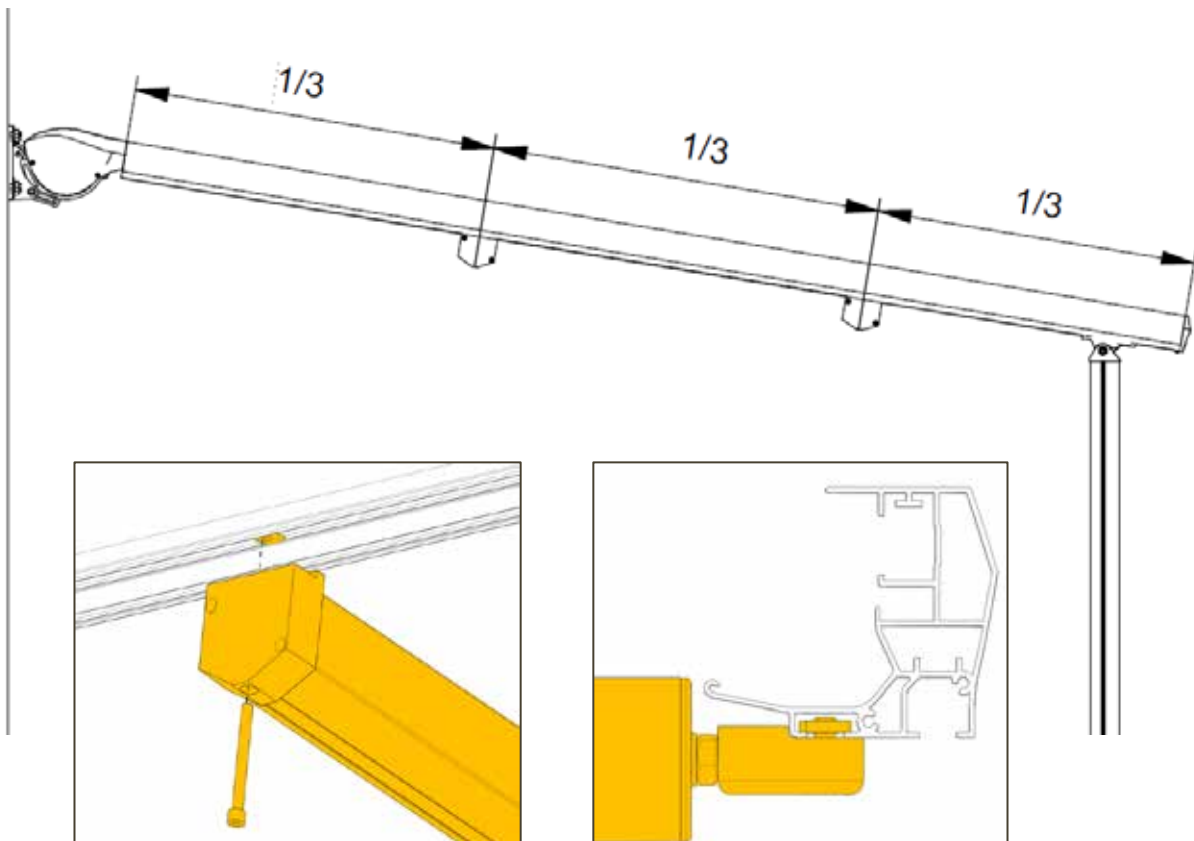
5.3 Spacers / fabric support profiles

Spacer profiles and fabric support profiles must be correctly installed and are vital parts for stability and function because if they are incorrectly positioned or omitted, they can significantly reduce the service life of the systems and can even result in damage and hazard by altering the distances between the guide rails. In the worst case, the fallbar can fall out of the guide and injure someone.

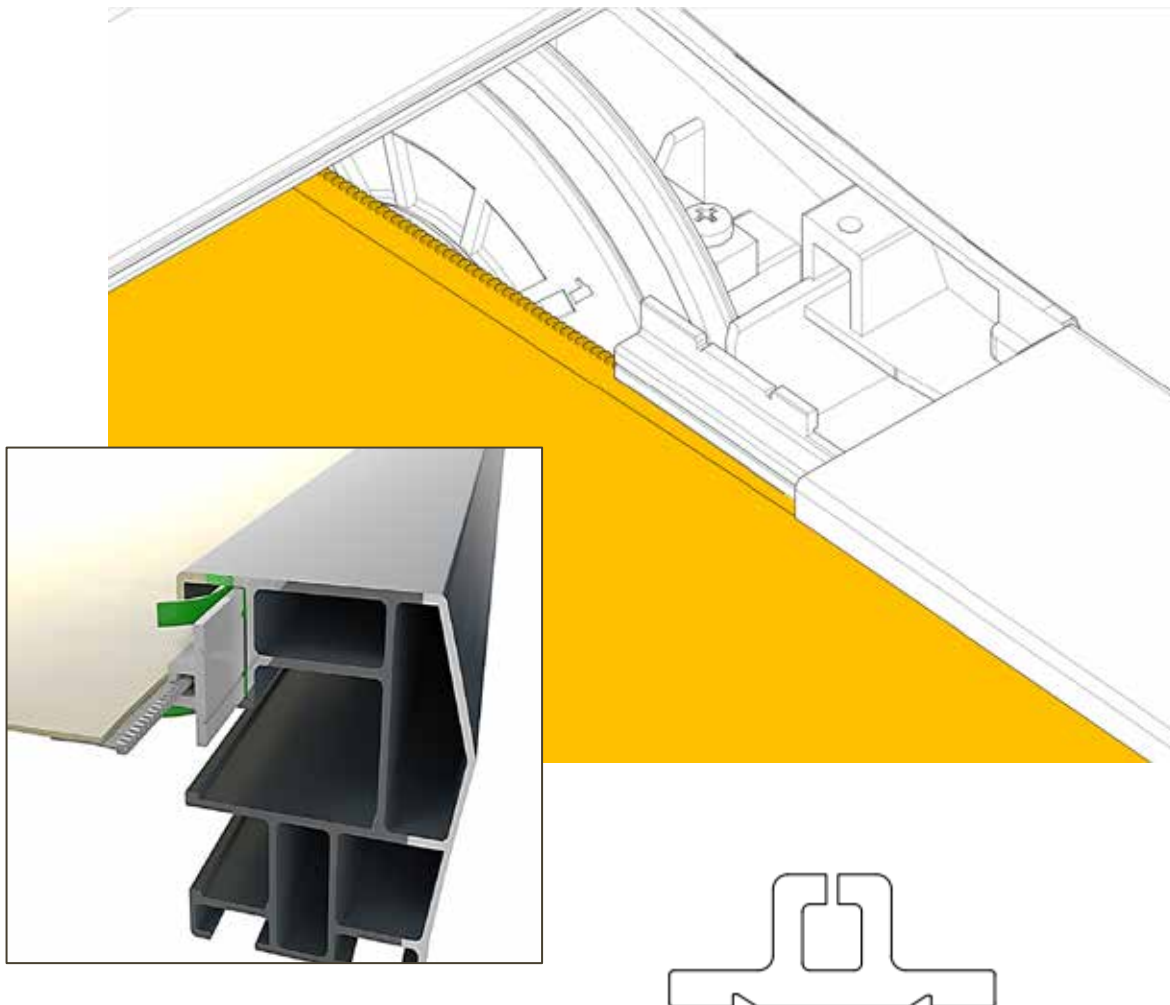
5.4 ZIP and ZIP guide rail

1. Wear results in greater frictional resistance – keep the guiding groove clean, replace worn inserts
2. Replace damaged guide inlays – zip should not catch or chafe.
3. Friction of the zip in the guide inlays can cause noises (squeaking) – this can be prevented by regularly spraying with PTFE spray.
